Marine View Park Final Restoration Report

June 30, 2010
Normandy Park, WA

Cascade Land Conservancy

KCD Marine View Park Community Restoration Program 2009 Grant

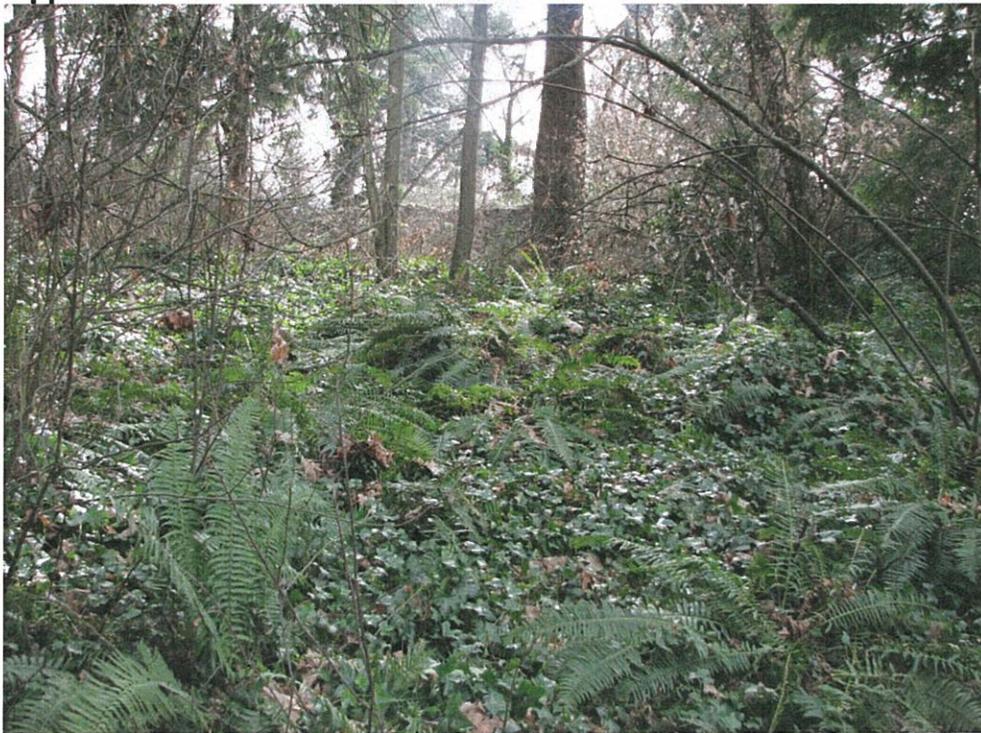
NE corner of Restoration Area behind Park entrance sign
Photo Point 1 (see Precondition Photo Point map in Appendix B.3 for spatial reference)

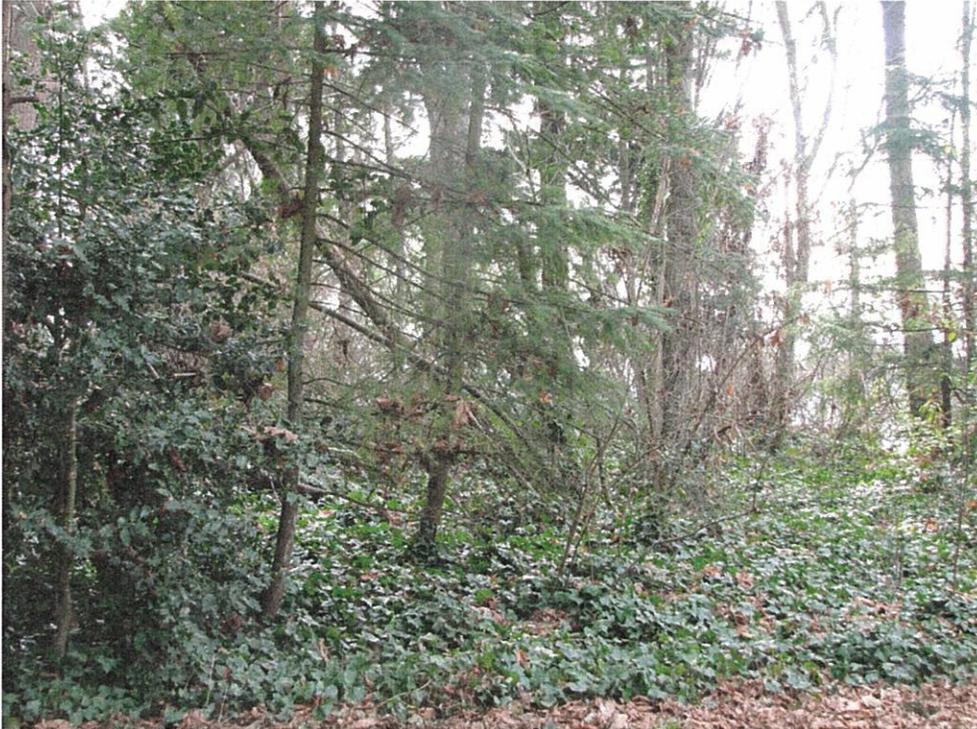
NW corner of Restoration Area near large debris pile
Photo Point 2

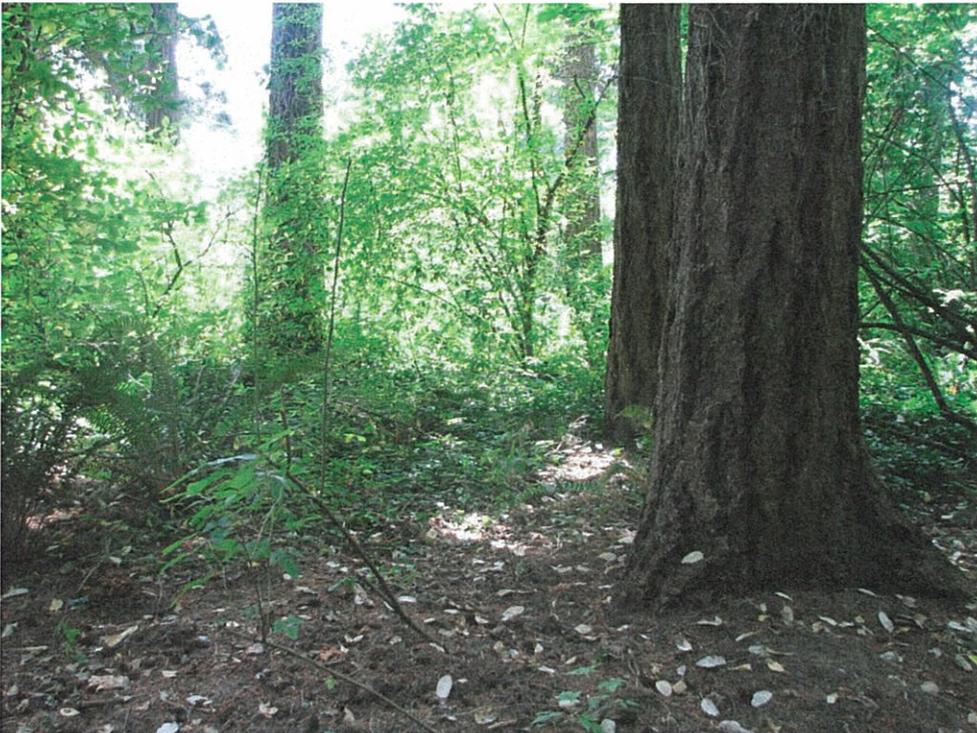
Eastern border of Restoration Area
Photo Point 3

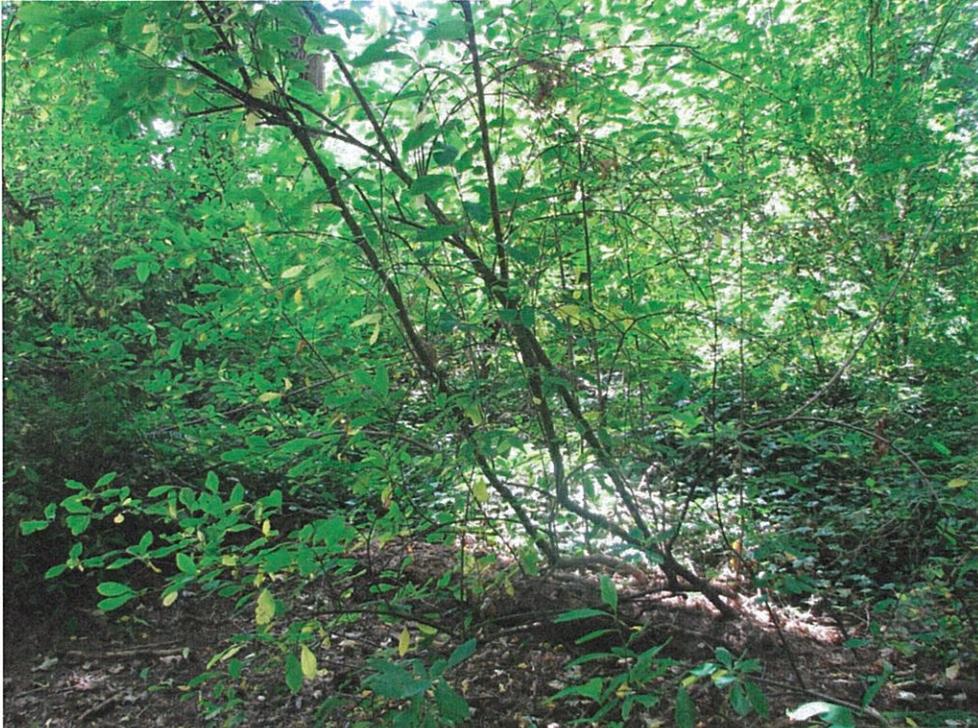
Western border of Zone 4 in Restoration Area across Main Trail
Photo Point 4

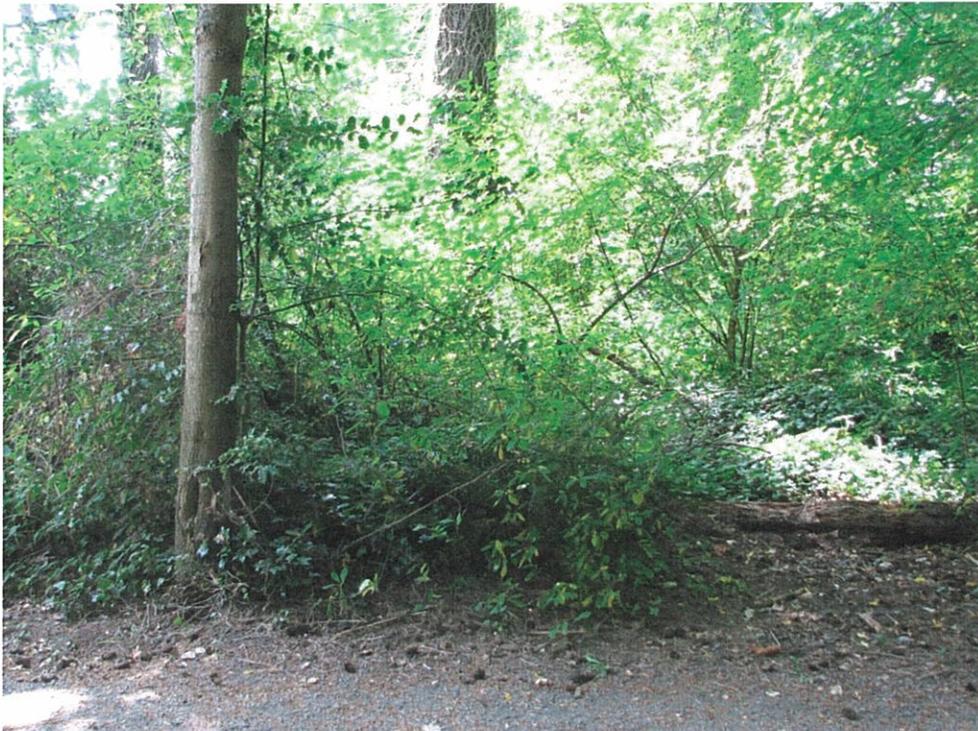
Southeastern portion of Restoration Area viewed from Main Trail
Photo Point 5a

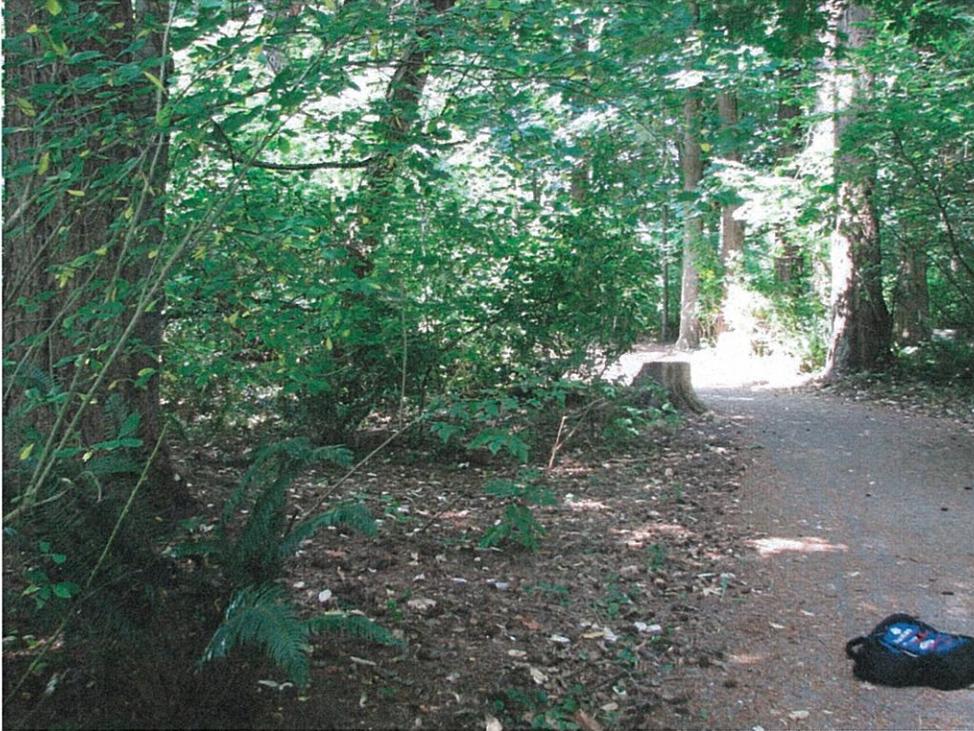
Looking north up Main Trail from southeastern portion of Restoration Area
Photo Point 5b

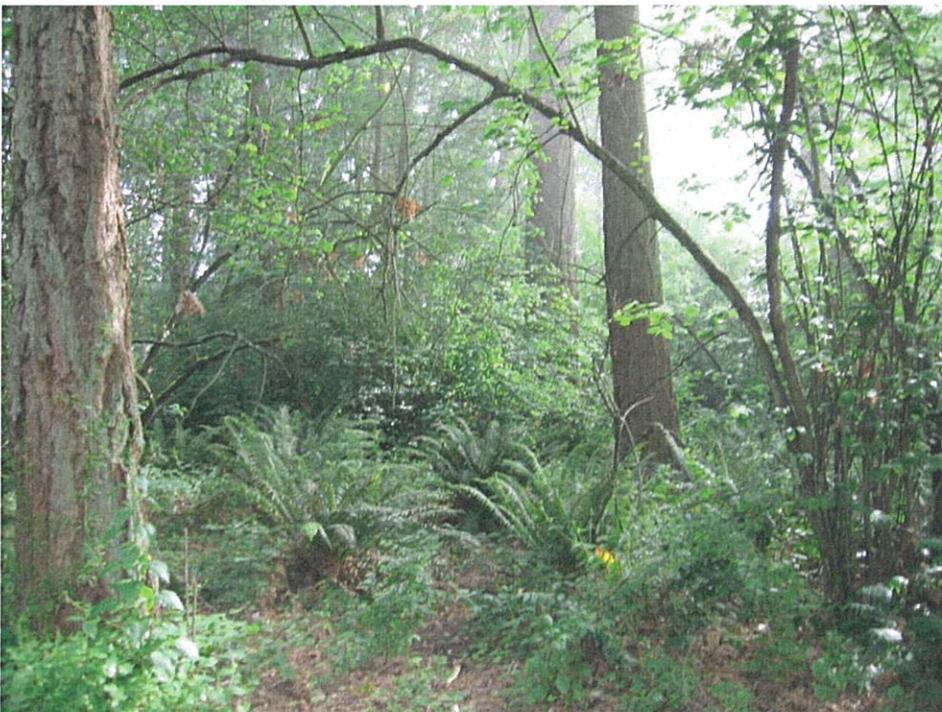
NE corner of Restoration Area behind Park entrance sign
Photo Point I

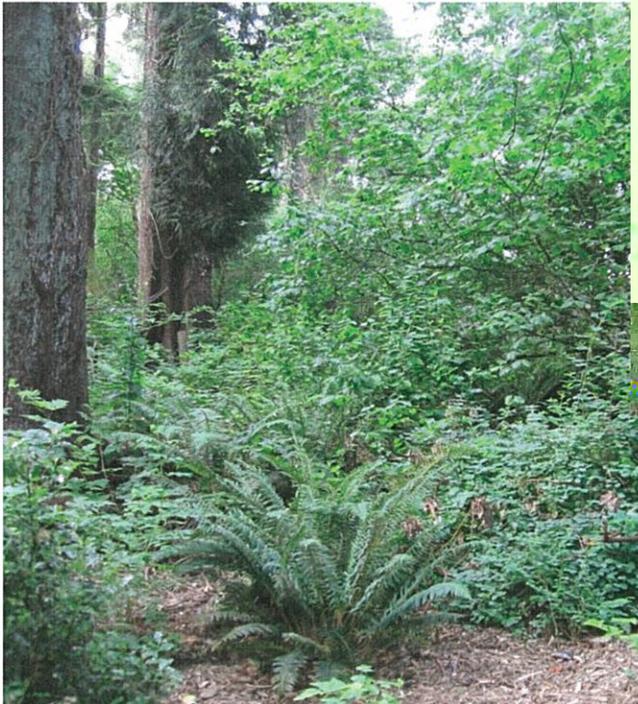
NW corner of Restoration Area near large debris
Photo point 2

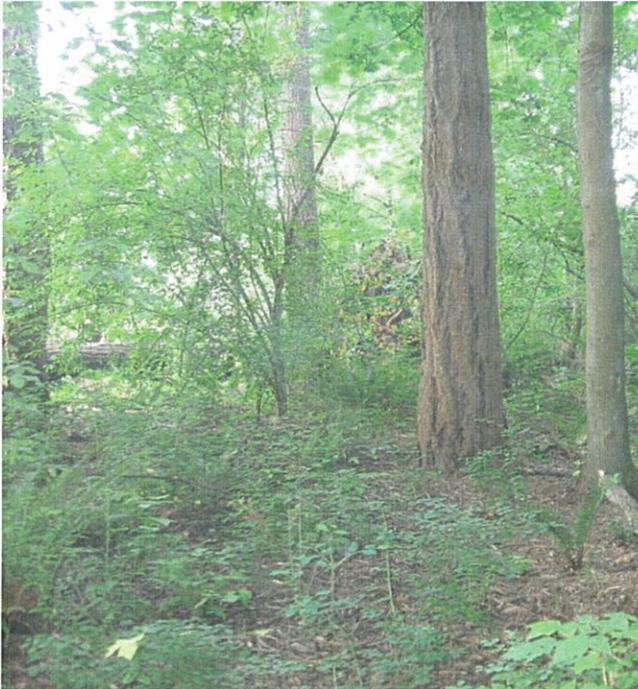
Eastern border of Restoration Area
Photo Point 3

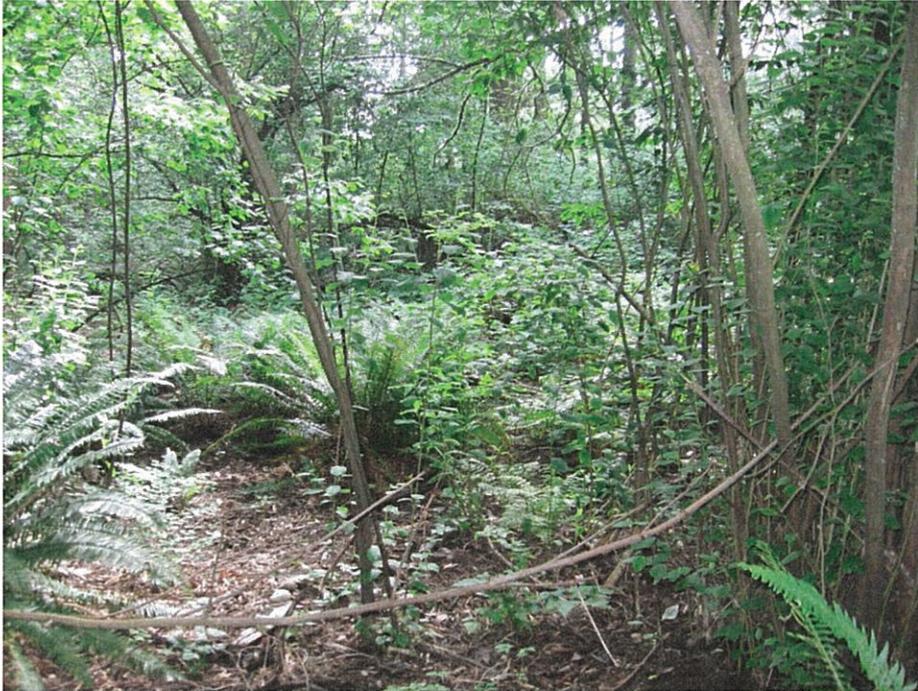
Western border of Zone 4 in Restoration Area across Main Trail
Photo Point 4

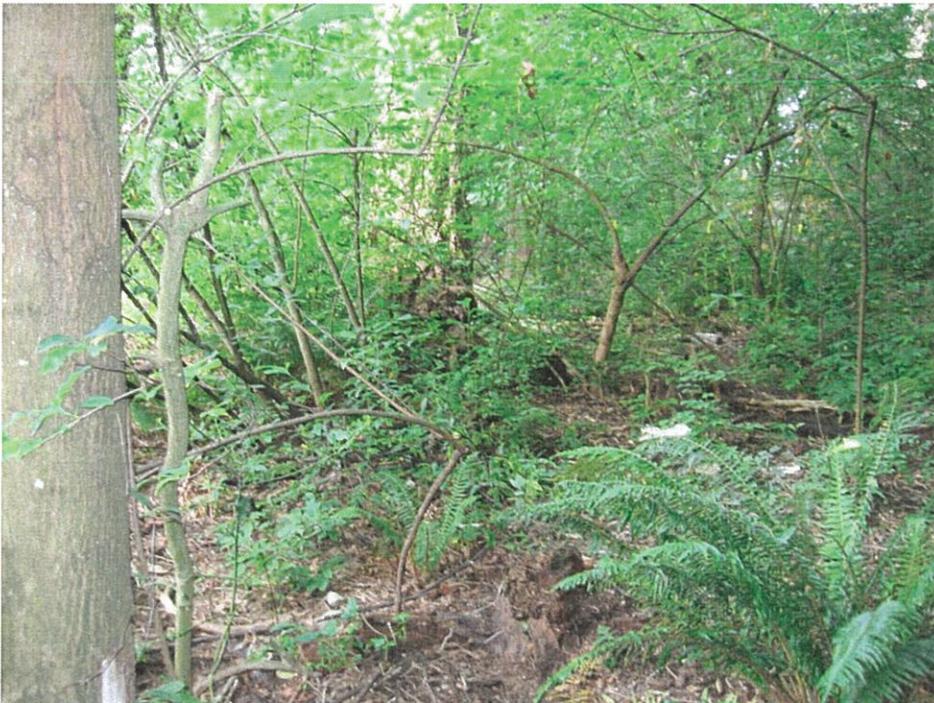
Southeastern portion of Restoration Area viewed from Main Trail
Photo Point 5a

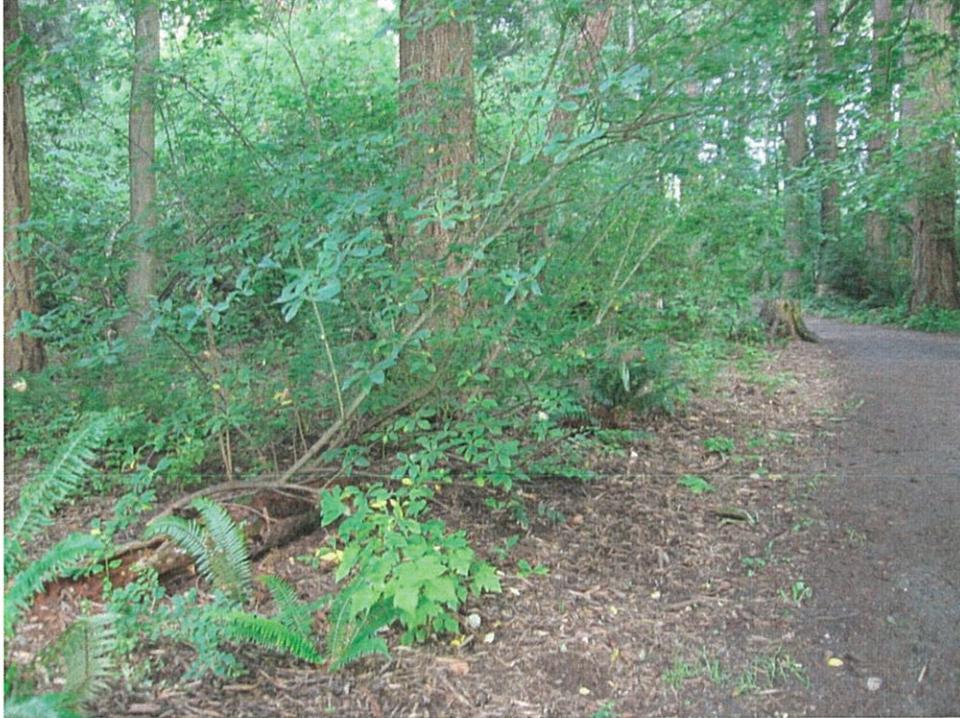
Looking north up Main Trail from southeastern portion of Restoration Area
Photo Point 5b
