The City of Normandy Park Draft Shoreline Inventory and Characterization Report

September 2010 **DRAFT**

Prepared for the City of Normandy Park by:
King County Water and Land Resources Division
201 South Jackson Street, Suite 600
Seattle, Washington 98104

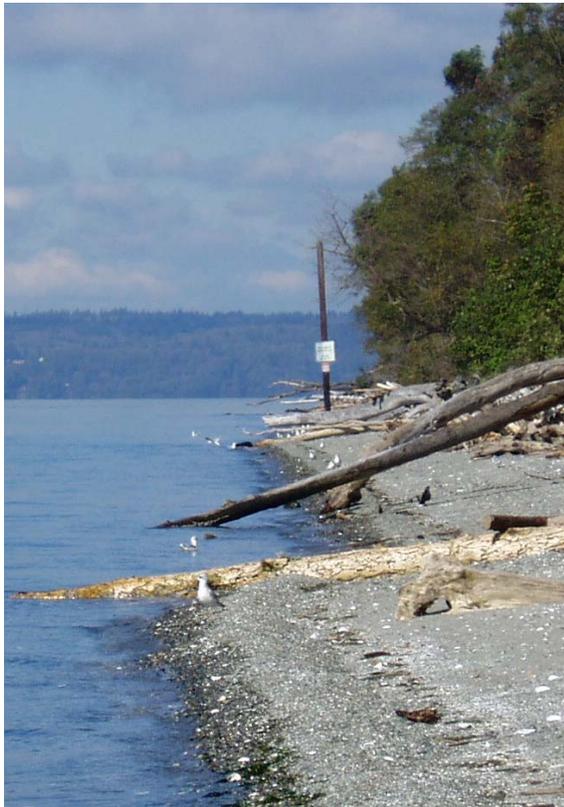
Figure 1 Shows the direction of sediment drift is towards the sign in the background of the picture. Sediment has built up, via littoral drift, on the log in the foreground (Photograph from Coastal Geologic Services).

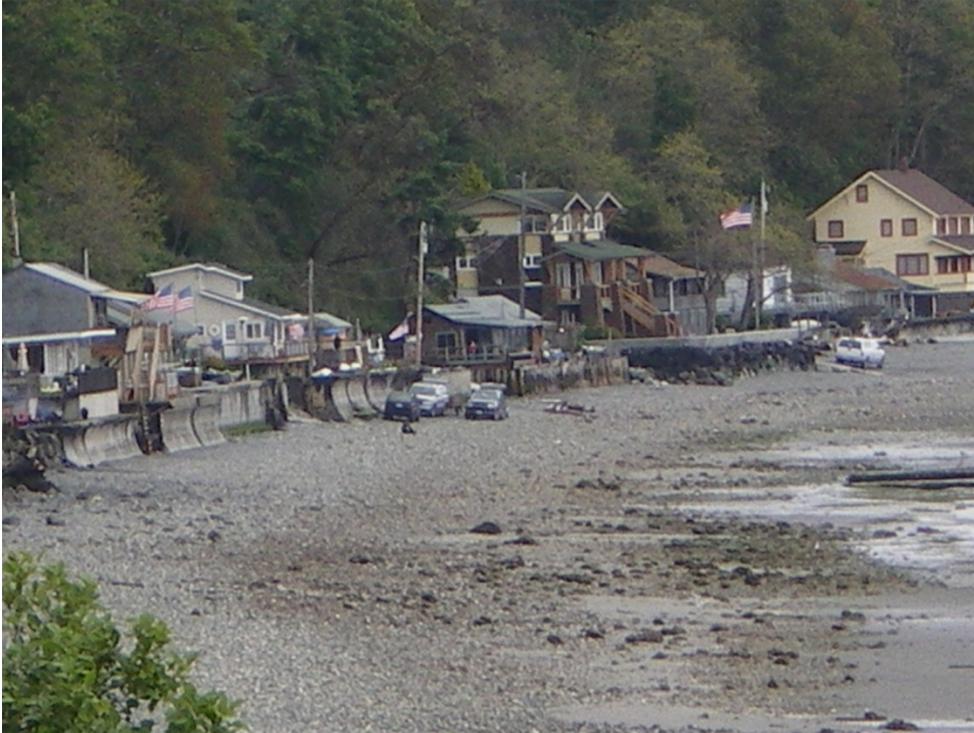
Figure 3 Shows the development pattern in Segment 1 and also shows that residents regularly drive on the beach in order to access their houses.

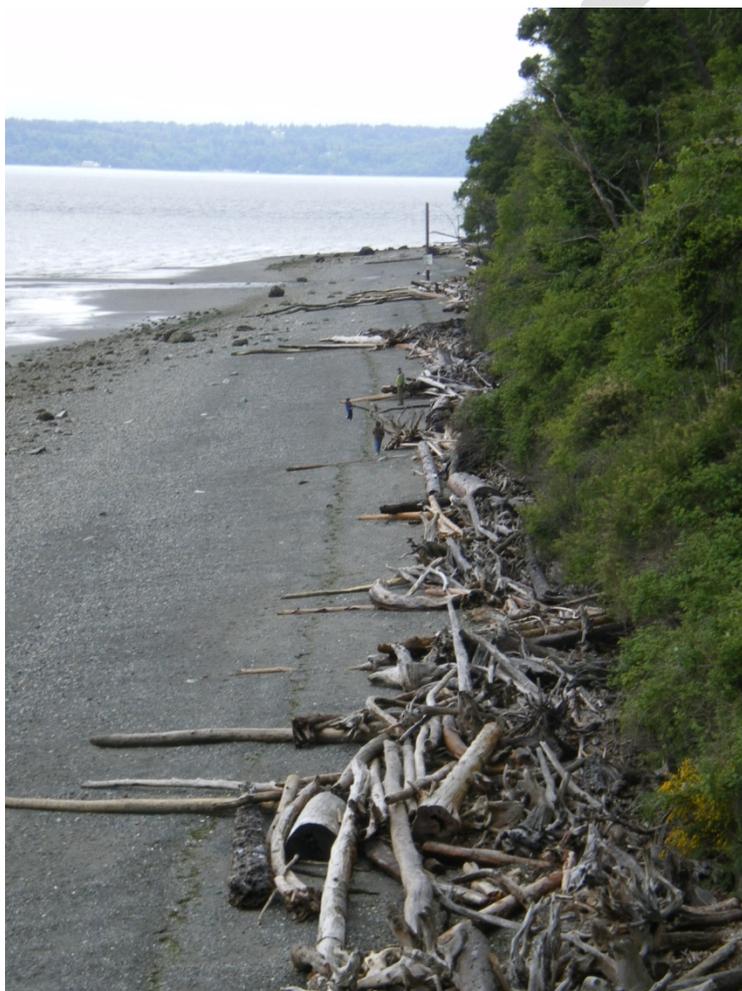
Figure 4. The picture shows drift log accumulations occurring in Marine View Park.

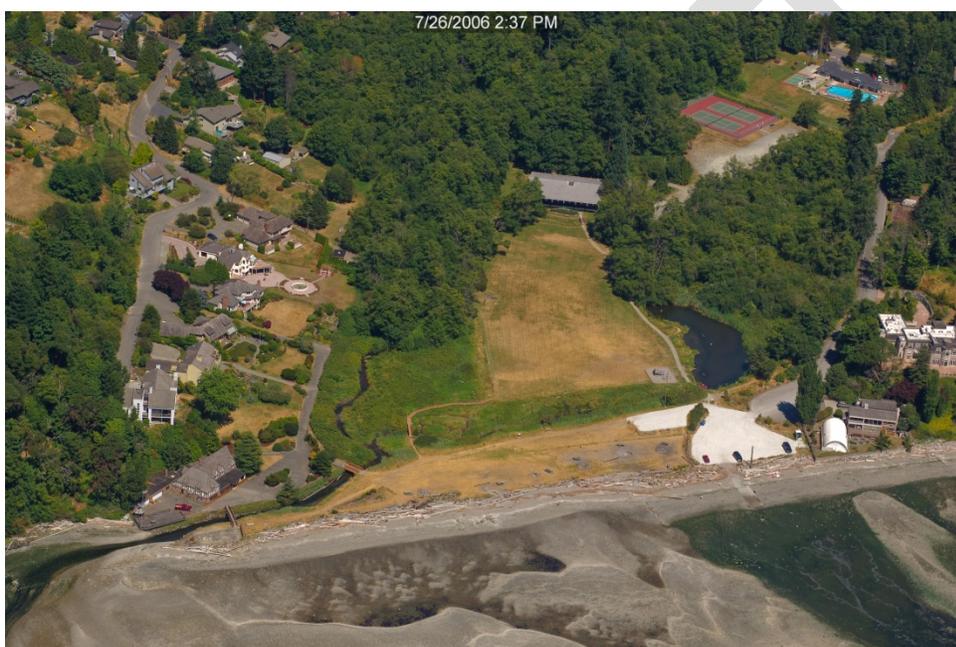
Figure 6. This oblique image shows the wetland complex at the mouth of Miller and Walker Creeks (photograph from WADOE).

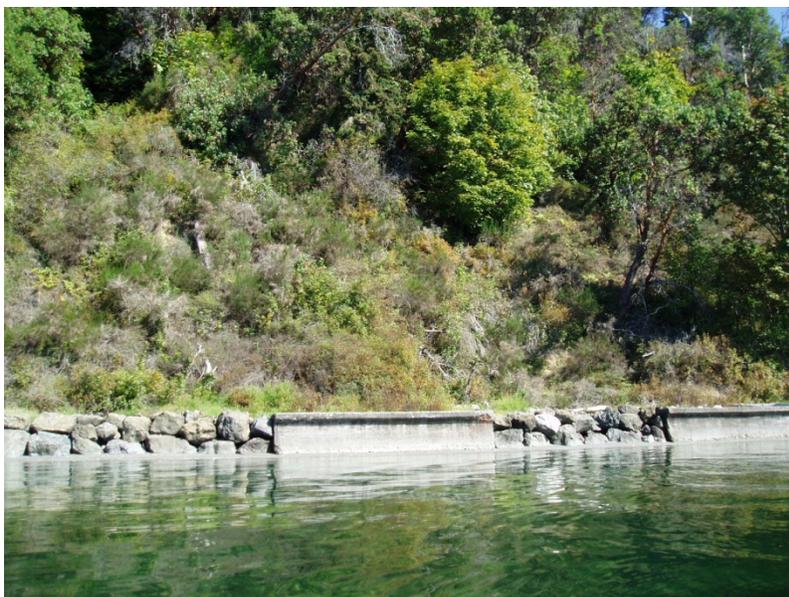
Figure 7. Removal of the bulkheads at the toe of the slope at Beaconsfield is ideal candidates for restoration (Photograph from Coastal Geologic Services).

Beaconsfield is an active salmon recovery project being undertaken by the City and the Cascade Land Conservancy in the middle of this segment. The project involves purchasing approximately 1,000 feet of shoreline (27 vacant parcels) in order to undertake bulkhead removal. Most of the parcels are very skinny and have no upland access, but are bulkheaded (Figure 7). This stretch of shoreline ranked as the highest bluff restoration priority for the entire drift cell (Johannessen et al. 2005). There is a single house at the top of the bluff, which is located on a small promontory of land with steep slopes on three sides. The property owner also owns one of the shoreline properties. A feasibility study was done in 2006 (Johannessen et al. 2006) to look at how much of the bulkhead could be removed without endangering the house at the top of the bluff. This report showed that 535 feet of the bulkhead could be removed. Since then the Cascade Land Conservancy and the City have been acquiring properties in order to remove the portion of the bulkhead that was called out in the feasibility report. A follow up feasibility study will begin in 2010 to look at bulkhead removal alternatives.

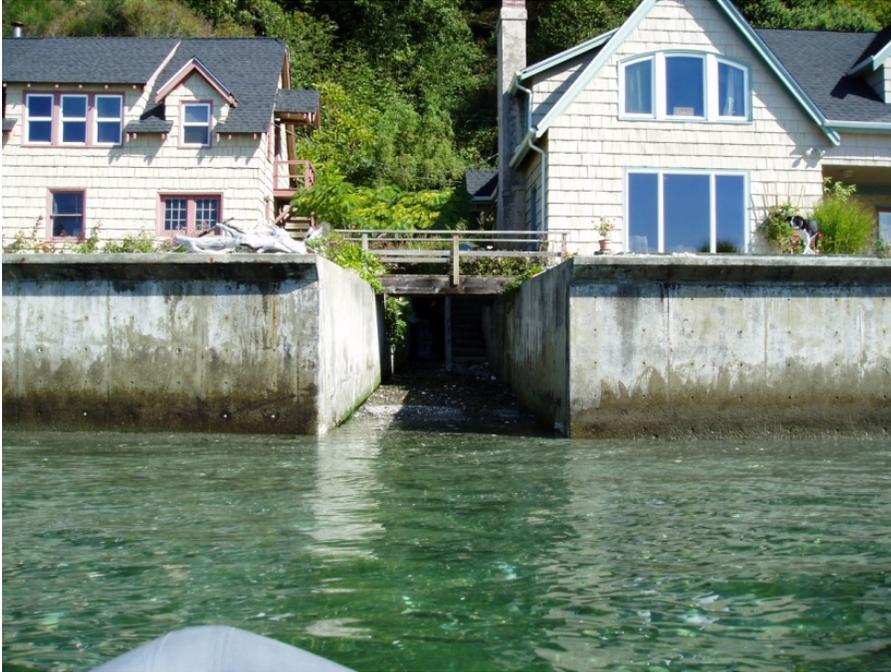
Figure 8. The unnamed stream is currently high constrained at the mouth by two houses (Photograph from Coastal Geologic Services).

Just north of this location is a highly constrained stream mouth, which is pinched between two houses (Figure 8). If this stream mouth were restored, the location has the potential to provide excellent salmonid rearing habitat (Johannessen et al. 2005). However, this restoration would likely require removing at least one of the houses, if not both.

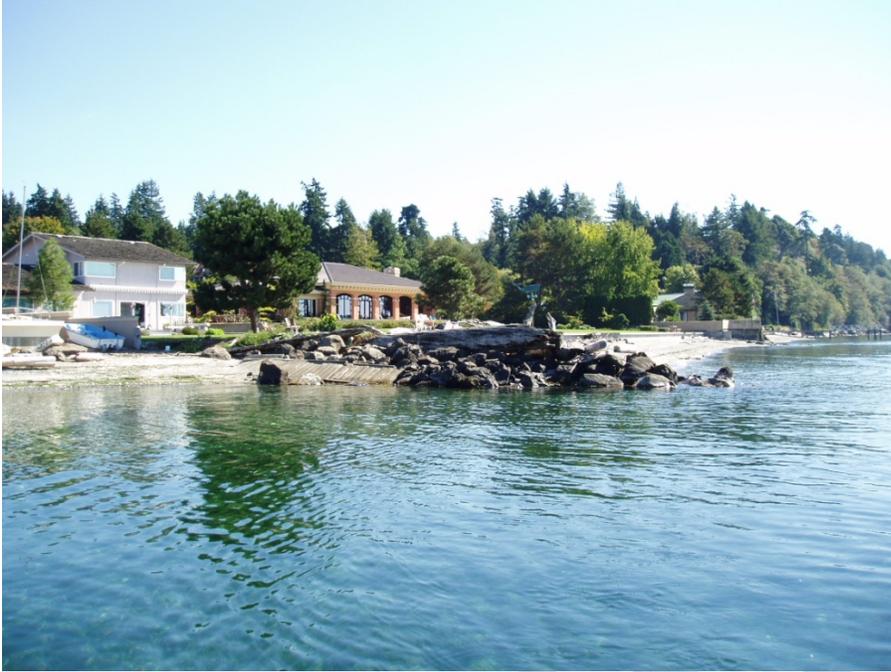
Figure 10. The groin in the foreground could be removed to improve sediment transport processes.

Potentially related to restoring the mouth of Normandy Creek, the large groin noted above could be removed as part of shoreline redevelopment (Figure 10). This would allow sediment transport to be restored.

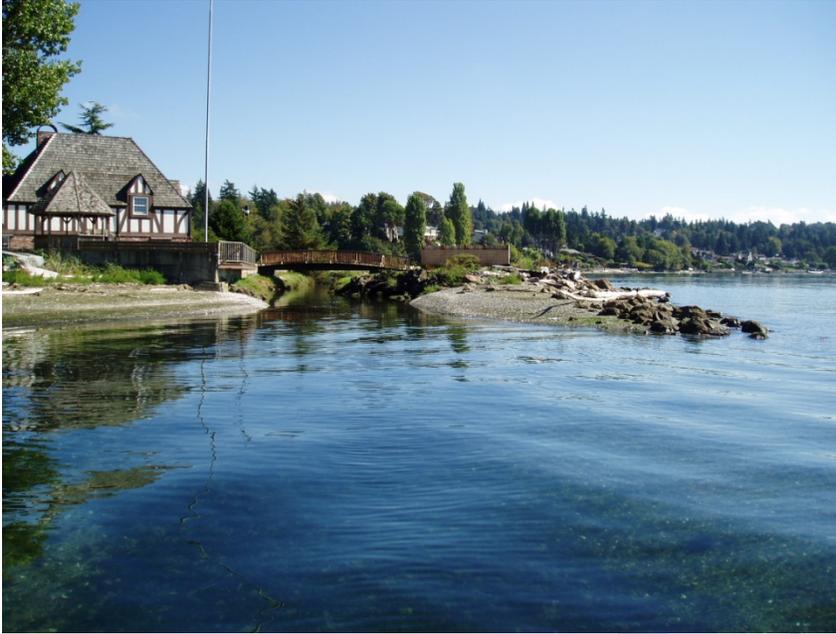
Figure 11. Photograph shows the outlet of Miller and Walker Creeks. Note the bridge over the creek, riprap along both sides of spit and helicopter platform on spit.

- The helipad, bridge, and the shoreline armoring surrounding the spit could be removed (see Figure 11)
- Work with the private residence on the right bank of Miller/Walker Creek to remove the overwater platform.
- The two acre area of historic wetland that is currently managed as lawn could have the grass removed and be revegetated with native wetland plants.
- The created pond near the outlet of Walker Creek could have the outlet dam removed so that water levels in the pond feature fluctuate naturally.
- Remove the road and boat ramp at the base of the spit.
- Look at ways to increase salt water inundation to the area behind the beach berm.

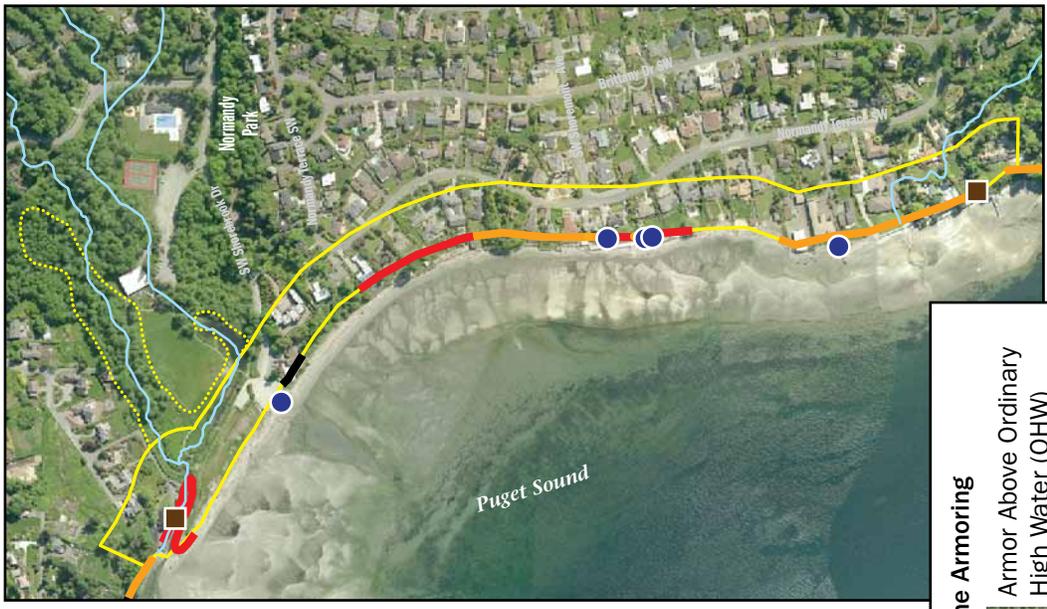
33b. Coastal Features

- Groin
- Dock
- Ramp

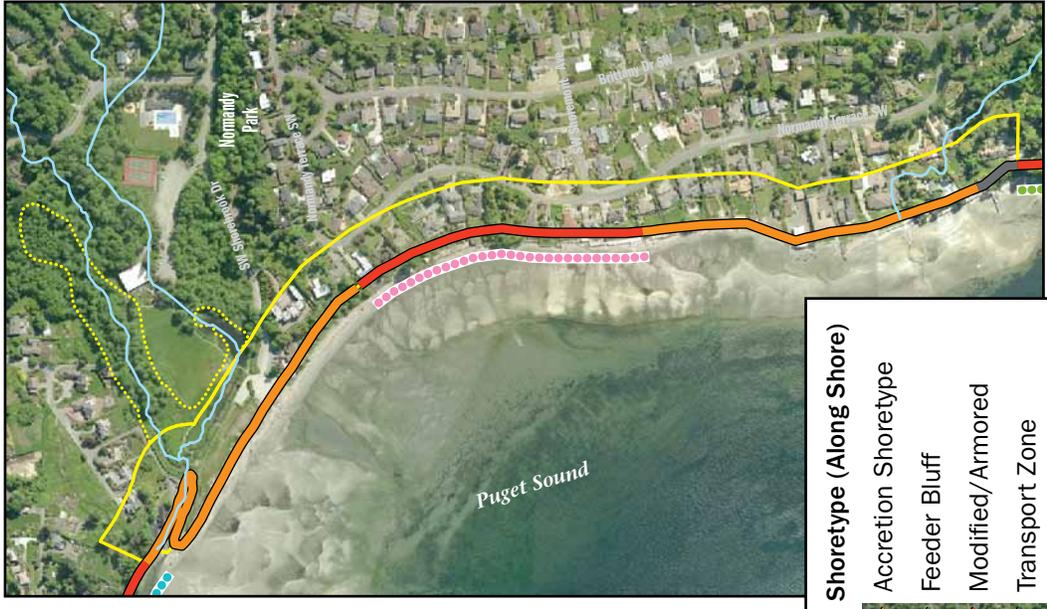
33a. Current and Historic Shoretype

- Feeder Bluff
- Feeder Bluff Exceptional
- Potential Feeder Bluff
- Not Feeder Bluff
